## Newton Corner

In this study area, we noticed many problematic patterns that involved inaccessibility and unsafe facilities. This included poor surface conditions, and an inaccessible path through the Crowne Plaza Hotel. Also, curb cuts and signals were not always designed to the accessibility standards provided by the ADA. In this section, we discuss the areas for improvement found in Newton Corner as well as potential solutions for these problems, as shown in Figure 15.

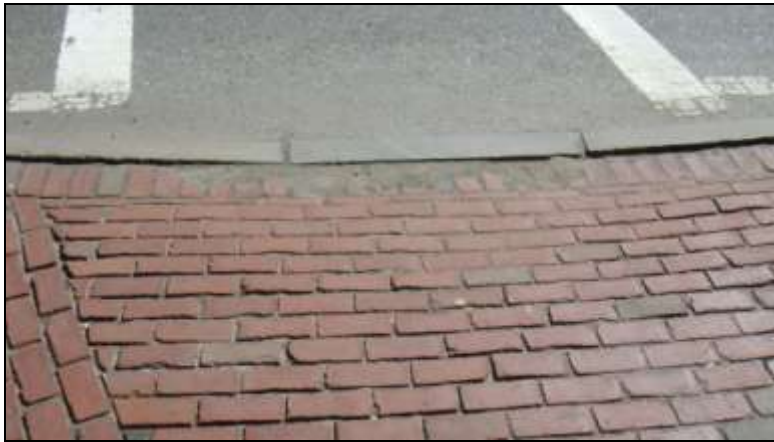
- 2. Hazardous Brick Surfaces:** Washington Street, for example, has a partial brick surface, as shown in Figure 16. Brick surfaces are extremely difficult to maintain and can be hazardous. The ADA suggests uneven surfaces such as bricks should be avoided.

**Figure 2: Brick Surface along Washington Street**

*Recommendation: Replace with pressed concrete.* We recommend replacing the brick surfaces with pressed concrete. Pressed concrete maintains some of the aesthetic appeal of brick while providing a safer traveling surface. This can be implemented systematically over time. As the brick degrades, pressed concrete could be used as a replacement. An example of pressed concrete is shown below in Figure 17.

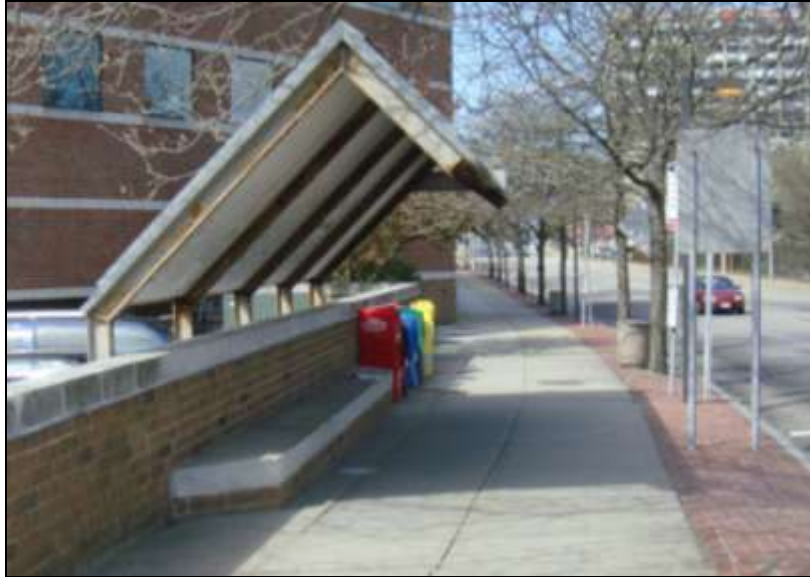
- 4. Lack of Proper Bus Stop:** At the south side stop, we found that the bus shelter was open and unattractive. This current shelter does not protect the bus users from the elements, as displayed in Figure 18. Another challenge at this bus stop was a lack of bicycle racks. There currently are no outside bike racks in the vicinity of the bus stop.

**Figure 4: Newton Corner south bus stop**

*Recommendation: Implement full bus shelter and bike racks.* We recommend implementing a full bus shelter at this stop. We were informed by our sponsors that this is the second-most used stop in Newton. Therefore, it is beneficial to shelter the bus patrons from the weather here. We also recommend implementing bike racks at this stop.

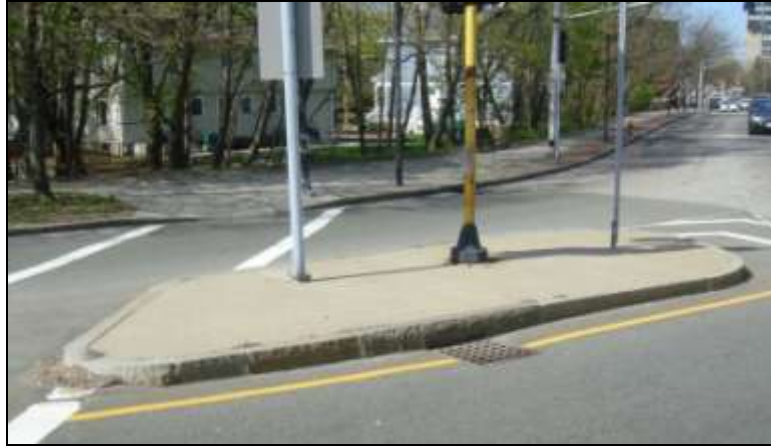
- 5. Inaccessible Walking Button:** A walking light at Park St and Centre Ave also presents a challenge. Here, we found that the walking button is in the center of a raised median thus making it inaccessible to the disabled and elderly, seen in Figure 20. Also, this walking button was not functional. This walking button presents a safety concern as well as violating the ADA regulations on its accessibility. Below are two options for improving the accessibility of the walking light.

**Figure 5: Inaccessible Walking button at Centre Avenue and Park Street**

*Recommendation: Create curb cuts on and off the median.* After fixing the walking signal itself, we recommend implementing curb cuts to allow access to the walking button. This will also elevate pedestrians from the level of traffic thus increasing the perception of safety.

*Recommendation: Relocate the walking button:* After fixing the walking signal itself, we recommend relocating the walking button to the edge of the median. This will make the button accessible from the median cut through.

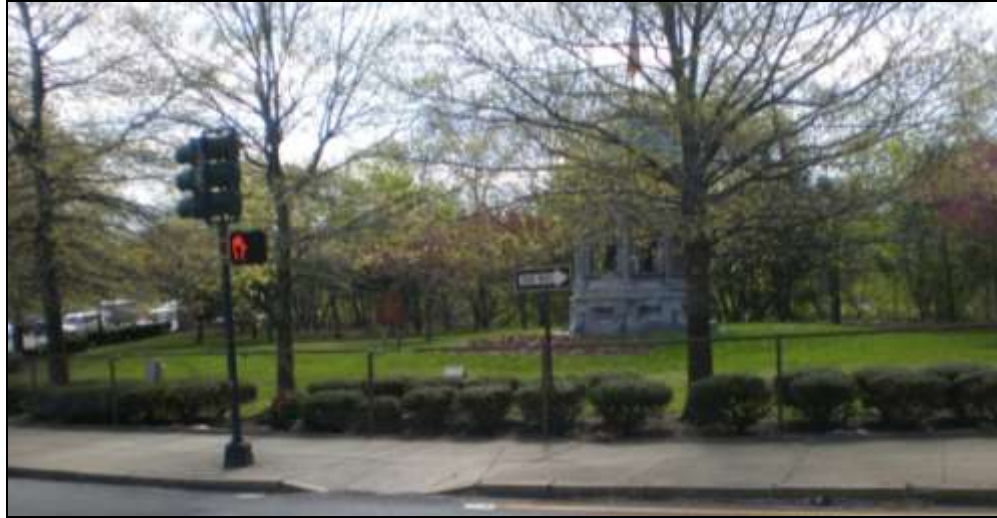
- 6. Closed Green Space:** In Newton Corner, there are not many green open spaces. Therefore, an area for improvement could be the Memorial Bell Park that is currently completely enclosed by a fence, as evident in Figure 21. This area has the potential to be a public area that would attract pedestrians and also offer them a safer path to travel.

**Figure 6: Bell Park on the north side of Newton Circle Rotary**

*Recommendation: Open the park:* We recommend opening this park to the public. This could be opened from dawn until dusk in order to prevent problems with misuse, such as vandalism. This will allow residents and employees to enjoy a green space.

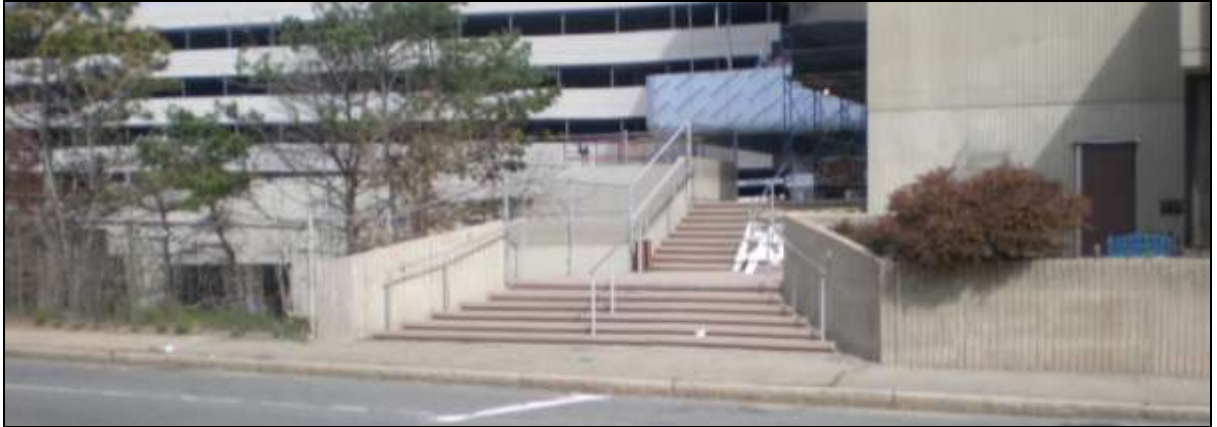
- 8. Inaccessible Walking Path:** An inaccessible path through the Crowne Plaza hotel was identified as a challenge. This cut through passes over the Massachusetts Turnpike connecting the north and south sides of the village center, shown in Figure 22. However, on the south side, there is a stairway preventing all disabled persons and many elderly from utilizing this path. Without the ability to use this path, pedestrians must walk around the west side of the rotary, which is a long, indirect path for many. During a walkthrough of the area, we noticed an elderly man using a cane traveling around this corner.

**Figure 7: Crowne Plaza path - south side**

*Recommendation: Implement a ramp.* We recommend the implementation of a pedestrian ramp on the south side of the path to allow access to all persons in accordance with ADA regulations.

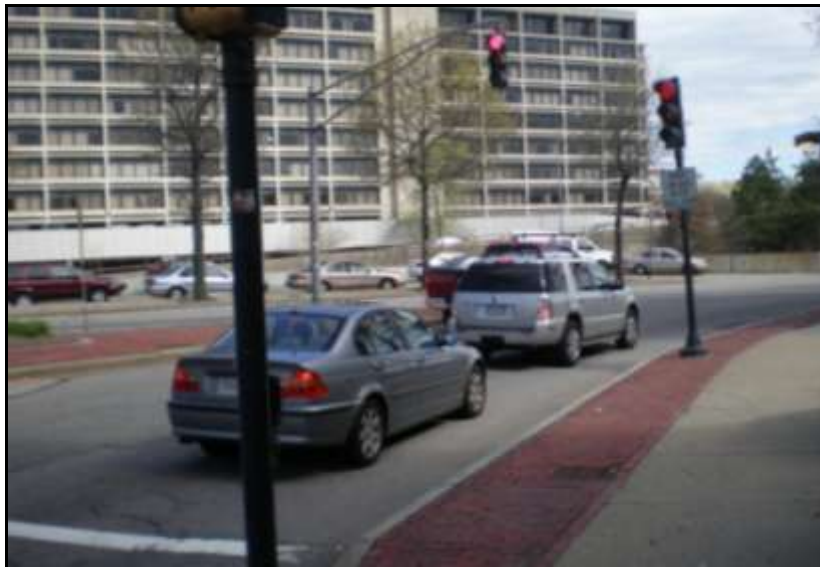
- 9. Improper Placement of Traffic Signals:** The traffic signals for the right turn on Centre Street at the intersection of Centre Avenue are located after the crosswalk, as shown in Figure 23. This causes cars stopped at the light to block the crosswalk and cause a hazard for pedestrians.

**Figure 8: Traffic signals at Centre Street and Centre Avenue**

*Recommendation: Change traffic signals.* We recommend moving the light on the median past the crosswalk to the same location as the other traffic light on the

median. Also, we recommend removing the traffic signal on the right hand side of the road altogether.

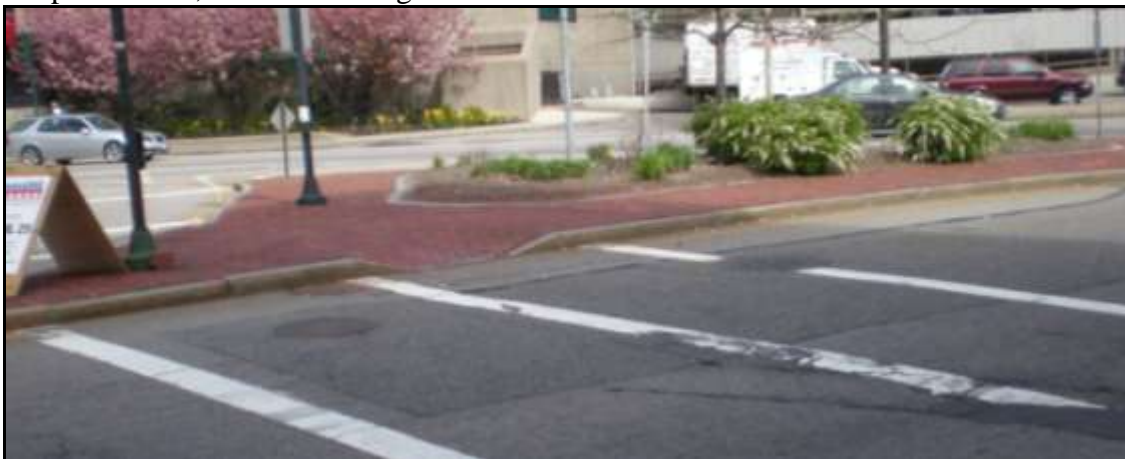
- 11. Uneven Median:** The median on Centre Street at the intersection with Centre Avenue is not a level surface and may cause some difficulties for disabled pedestrians, as shown in Figure 24.

**Figure 9: Median at Centre Street and Centre Avenue**

*Recommendation: Level the surface.* We recommend leveling this surface in order to allow safer travel to all pedestrians.
