Chestnut Hill - Route 9

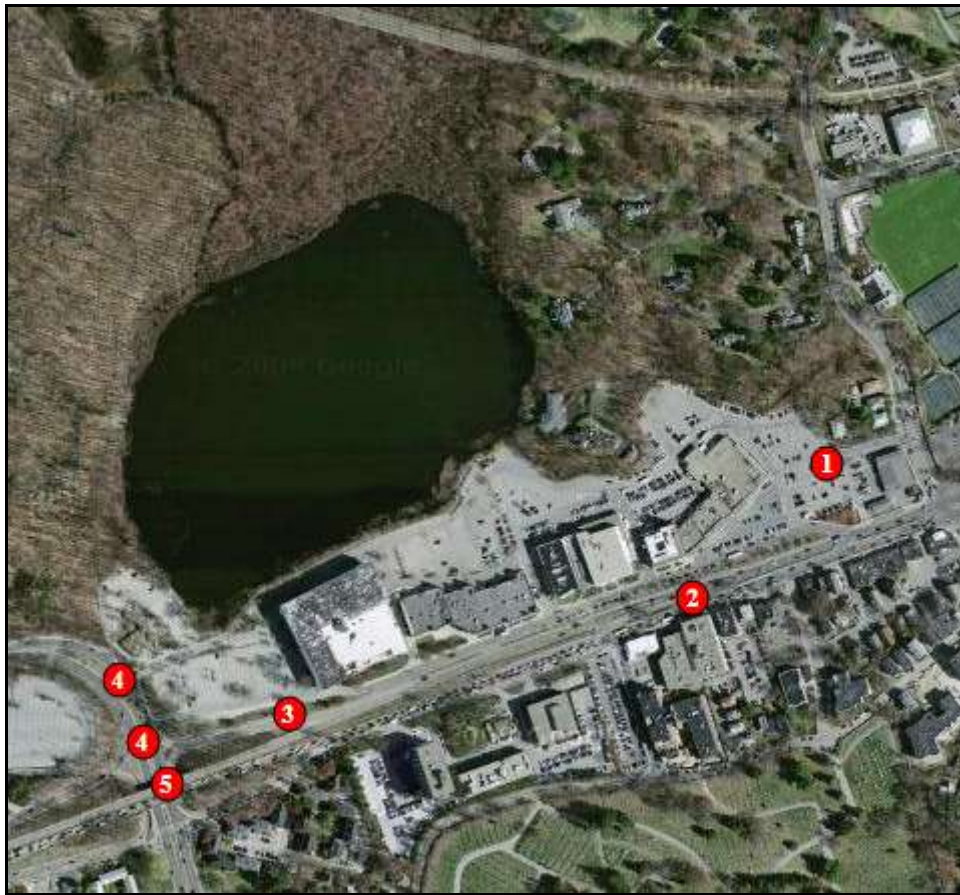
Figure 1: Chestnut Hill Problems and Opportunities Map

In Figure 33, we highlight challenges pedestrians face in this study area; each problem is signified by a red circle with a number corresponding to the following text.

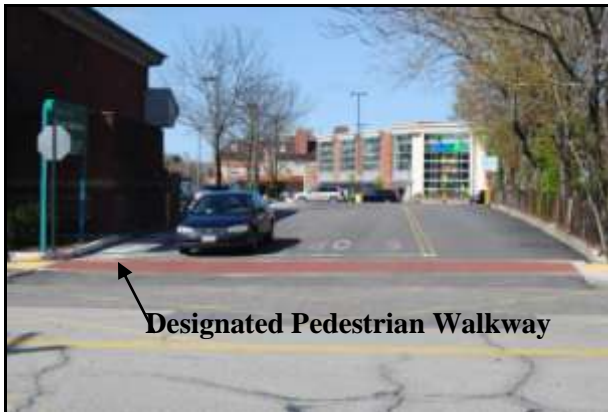
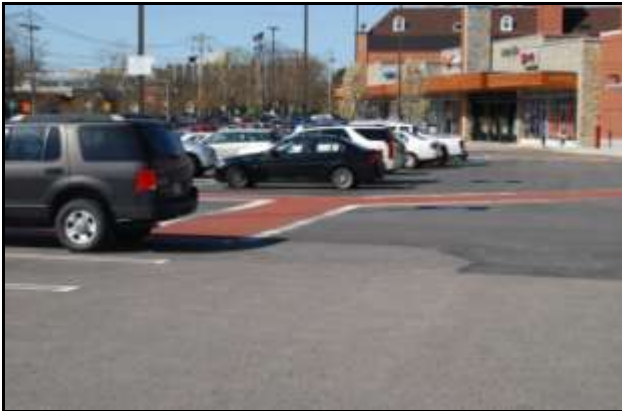
**Figure 2: Back entrance to the Mall at Chestnut Hill Shopping Center (left);
Crosswalks in Shopping Center Parking lot (right)**

- 1. Dangerous Interactions in Parking Lot:** The first problem we observed were pedestrians cutting through a parking lot entrance to the Chestnut Hill Shopping Center. The cut through begins behind a CVS Pharmacy on Hammond St. with a designated pedestrians area marked by white stripes. This can be seen below in Figure 34. However, where the parking lot begins the designated pedestrian path ends, leaving pedestrians to choose their own paths and causing potentially dangerous interactions between motorists and vehicles.

Recommendation: Install Crosswalks. We recommend that the crosswalks throughout the Chestnut Hill Shopping Center, shown in Figure 34, extend to the pedestrian designated entrance by CVS. This would be beneficial to pedestrian safety. Having pedestrians follow a designated path allows vehicles to be more aware of where pedestrians are likely to travel.

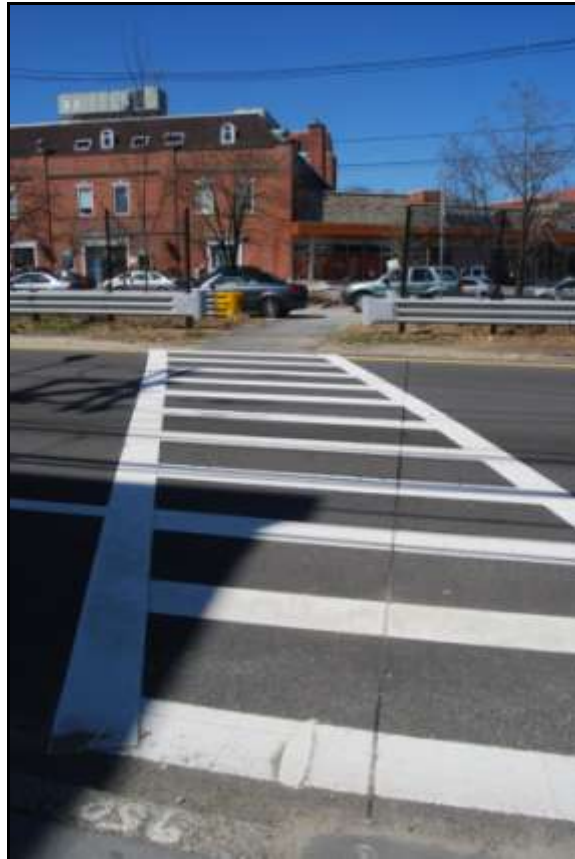
Figure 3: Un-signalized Crossing on Route 9

- 2. Unsafe Designated Crossing:** There is a crosswalk across Route 9 located on the Brookline portion between Finagle-A-Bagel and the Chestnut Hill Shopping Center. This crosswalk is not safe for pedestrians to use because it is not signalized, and heavy vehicle traffic is almost always present at high speeds. Due to this, pedestrians cannot accurately determine on their own accord when a safe time would be to cross. This crossing is very intimidating and dangerous resulting in a lack of use. This crosswalk is shown in Figure 35. Below are two alternatives for improving safety at the crosswalk.

Recommendation: Remove the crosswalk: We recommend removing the crosswalk and encouraging people to use the two other crosswalks along Route 9, one at Hammond St. the other at Tulley St.

Recommendation: Implement a walking light. Alternatively, we recommend implementing a walking light, stopping traffic on both sides of Route 9, and allowing pedestrians to cross safely.

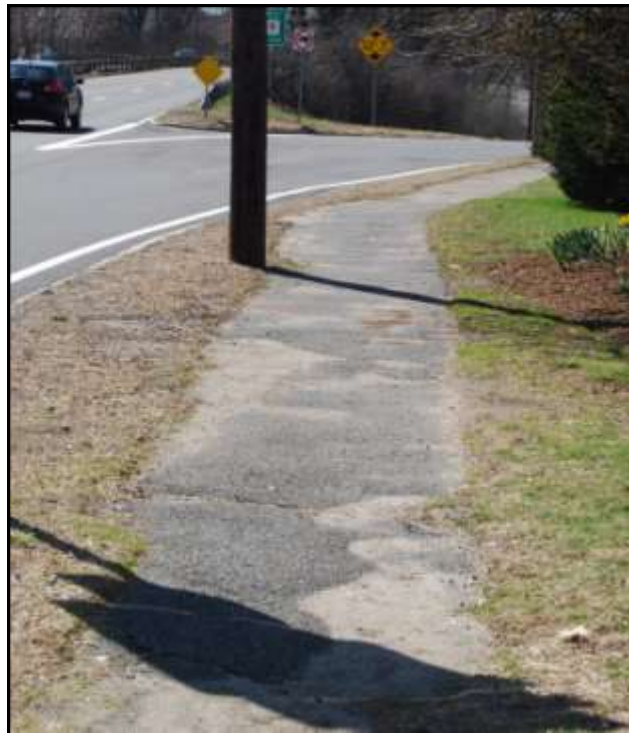
Figure 4: Poorly maintained sidewalk along Route 9 leading to Hammond Pond Parkway

3. **Inaccessible Sidewalk:** The sidewalk leading from Route 9 onto Hammond Pond Parkway on the westbound side is inaccessible, presents dangerous conditions for the elderly and disabled, and is not aesthetically pleasing. Where the off-ramp extends towards Hammond Pond Parkway, a sidewalk also begins. However, there are no crosswalks leading to this crosswalk and no curb cuts allowing those in wheel chairs access to this. Even when a pedestrian reaches this sidewalk, it is broken and covered in debris, which can present many tripping hazards to the elderly and disabled. The sidewalk looks as though it is not meant to be used. The beginning of this sidewalk is shown in Figure 36.

Recommendation: Replace Existing Facilities. We recommend that this sidewalk is replaced and new facilities such as curb cuts and crosswalks are installed with its replacement.

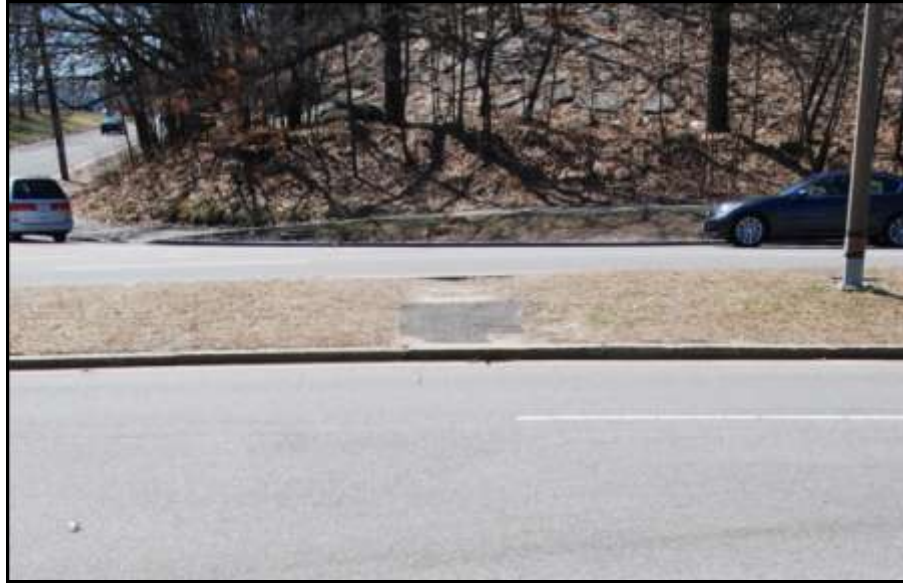
Figure 5: Potential crossing across Hammond Pond Parkway

4. **Hazardous Facilities along Hammond Pond Parkway:** The conditions of the sidewalk and facilities associated with it continue to be a problem along Hammond Pond Parkway.
 - a. **Hazardous Pedestrian Crossing without Proper Facilities:** Cars traveling southbound on Hammond Pond Parkway approach the intersection of Route 9 right after they take a sharp turn down a steep hill. Pedestrians do cross here;

the facilities seem to suggest a designated crosswalk because of a median with a paved patch of sidewalk. However, there are no crosswalks and no curb cuts leading to the median. This median is shown in Figure 37. As pedestrians cross here, they are presented with fast-moving traffic with poor visibility, putting them in danger.

Recommendation: Renovate or Replace Existing Facilities: We recommend that these facilities be repaired, replaced, or otherwise built to ADA regulations, providing the proper widths, even surfaces, and curb cuts with crosswalks leading up to them. Signalizing the crosswalks along Hammond Pond Parkway would also be beneficial to pedestrian safety.

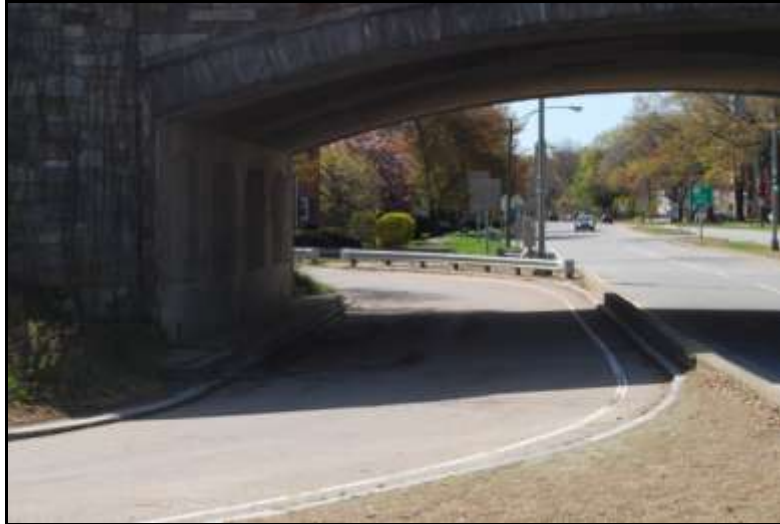
Figure 6: Route 9 Underpass

- 5. Pedestrians Use Underpass to Cross Route 9 without Facilities:** During our observations, many pedestrians were walking through the underpass without any designated facilities. The underpass is shown in Figure 38. To identify the reason for this, we observed where they were traveling. Some were walking through the underpass to use the crosswalks on the other side of Route 9 to cross Hammond Pond Parkway. Others were using the underpass to get from one side of Route 9

to the other. These paths are shown in Figure 39. Regardless of where they were traveling, using this underpass is extremely hazardous because it only provides a very narrow place to walk with cars traveling quickly around a sharp corner from Route 9. This area is likely to cause an accident between motorists and pedestrians.

Recommendation: Discourage the Use of These Facilities. We recommend that pedestrians should be discouraged from using this underpass. This can be done by encouraging people to use the crossings along Route 9 through signage. These signs will outline where pedestrians can get from the north side of Route 9 to the south side safely

Recommendation: Install Pedestrian Facilities along Underpass of Route 9. To solve this safety issue, new facilities need to be built to accommodate the pedestrians crossing through this underpass. In order to fit in new sidewalks and other facilities, the lanes through the underpass need to be narrowed. Narrowing street lanes is considered a method of traffic calming, which slows down traffic, also benefiting pedestrian safety.
