West Newton

We focused on four streets that intersect with Washington Street. In this section, we discuss the areas for improvement as well as potential solutions. Below is a map detailing where areas for improvement exist in West Newton.

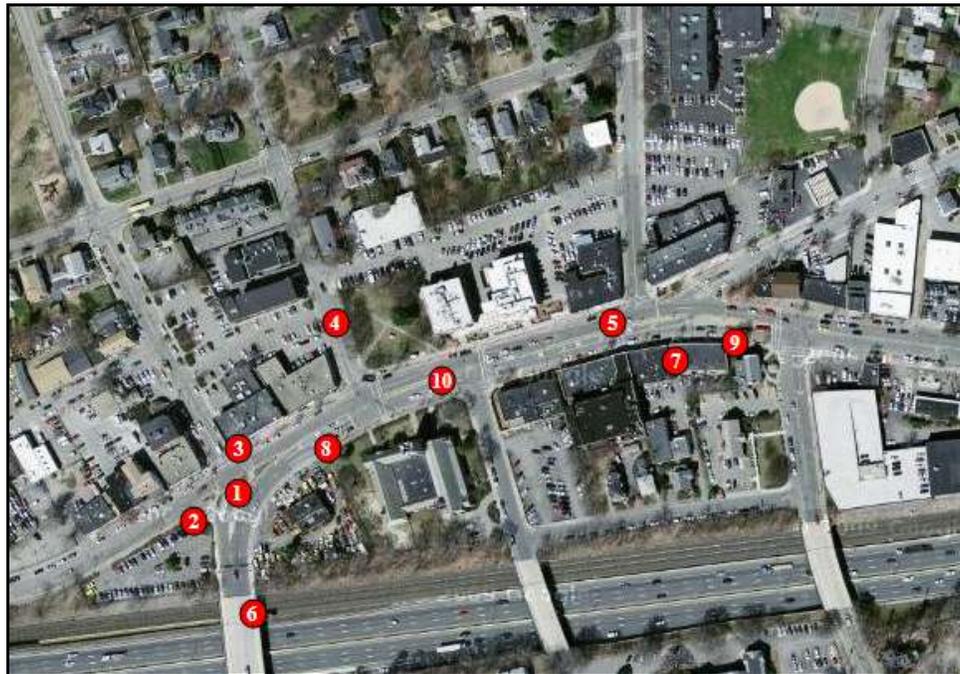
Figure 1: West Newton Problems and Opportunities Map

Dangerous interactions between congested vehicle traffic and pedestrians are common throughout West Newton. Additionally, many pedestrians choose their own crossings rather than using the designated crosswalks and walking lights. Other opportunities West Newton presents are improved accessibility to the commuter rail station, implementation of better bus shelters and bike racks, and the implementation of new crosswalks that could inform drivers where pedestrians are likely to cross. These problems and opportunities occur throughout this area including at each intersection of interest.

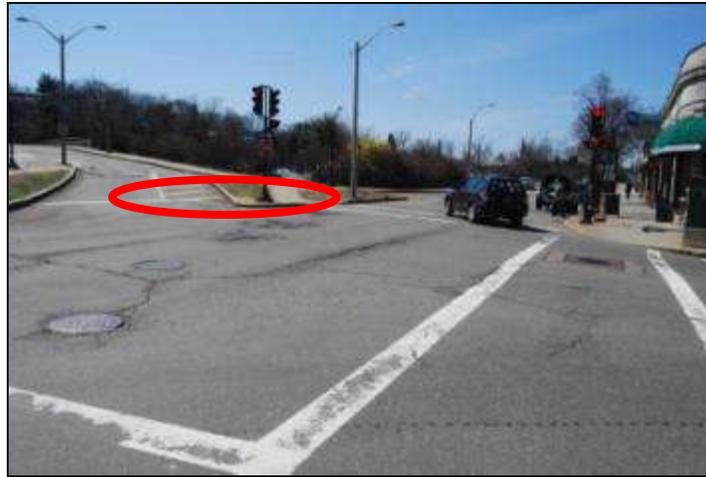
Figure 2: Potential New Crosswalk Location

- 1. Confusing Crosswalk Design:** The crosswalks at this intersection do not represent the paths pedestrians normally take and are not in the safest place for crossing through this area, as shown in Figure 9.

Recommendation: Implement a new crosswalk. We recommend implementing a new crosswalk across from Elm Street at the north side of the intersection with

Washington Street. This was a common path along one lane of traffic and would provide a safe place to cross.

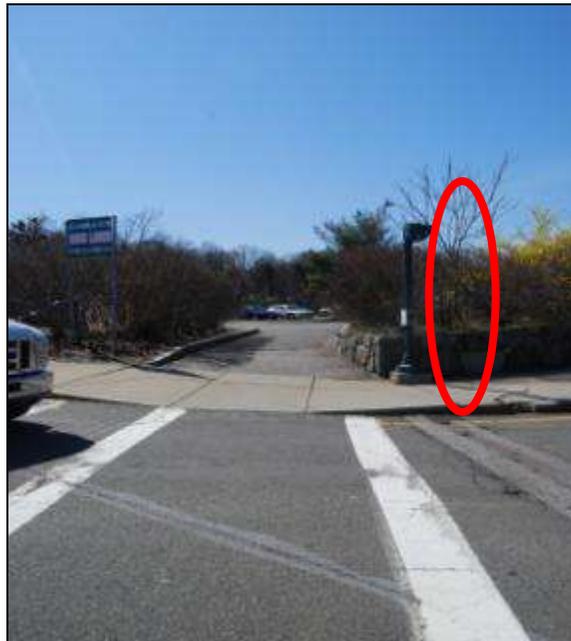
Figure 3: Walking Light Not Visible

- 2. Walking Light Not Visible:** As shown in Figure 10, the walking light is turned away from the crosswalk, making it impossible for a pedestrian to determine when the light indicates it is safe to cross.

Recommendation: Rotate the walking light. We recommend rotating the walking light back to facing the crosswalk to encourage pedestrians to use this facility.

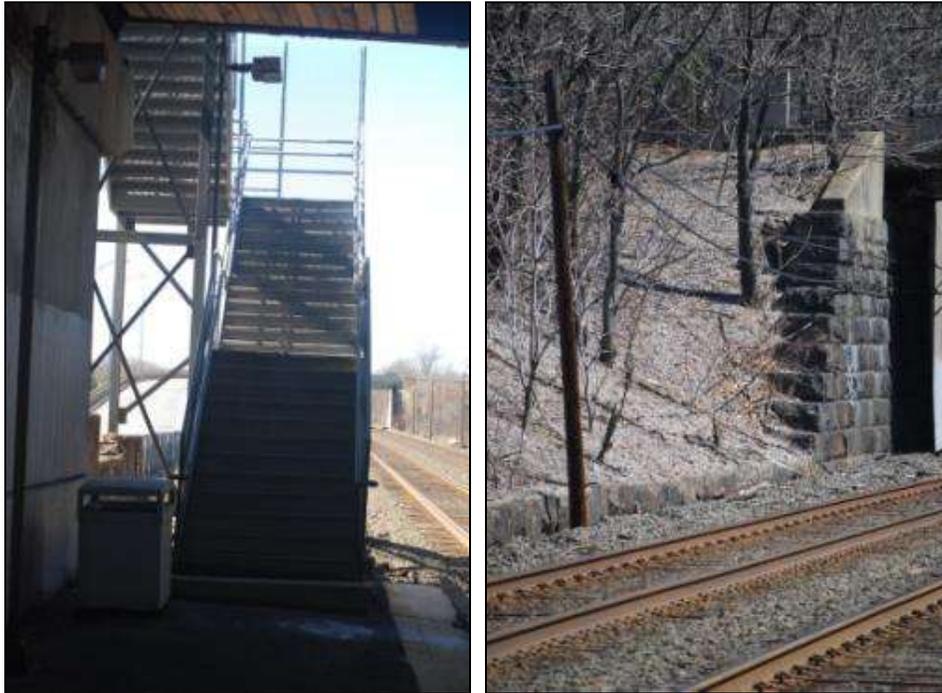
Figure 4: Inaccessible Commuter Rail Station

- 6. Inaccessible Commuter Rail Platform:** There are three commuter rail stops in Newton, none of which are handicap-accessible. Figure 11 shows the West Newton platform, which only has stairs leading down to it. Since the ADA requires that all public facilities be accessible to all persons, this portrays Newton in a bad light. Therefore, it is important to address this issue.

Recommendation: Construct a ramp to the Commuter Rail platform. We recommend that implementing a ramp at the stop in West Newton will make

Newton more accommodating to all persons. This ramp needs further planning and MBTA involvement and funding.

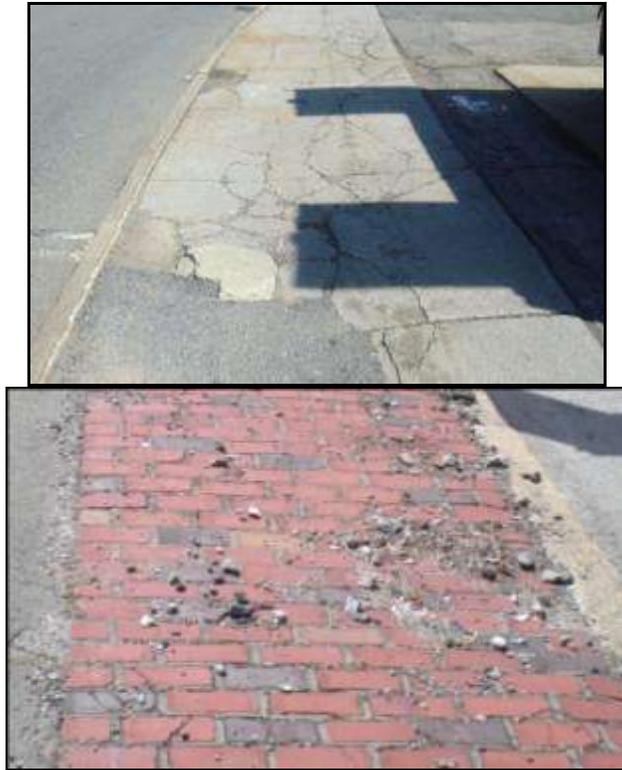
Figure 5: Cracked Sidewalk (left); Poorly maintained brick (right)

- 8. Sidewalks in Poor Condition:** The sidewalks in West Newton are generally in good condition; however, some areas feature cracked and broken sidewalks, as shown in Figure 12, creating tripping hazards that are particularly dangerous to the elderly and the disabled. At the same time, many sidewalks are lined with brick buffers and brick curb cuts.

Recommendation: Repair or replace sidewalks: We recommend repairing or replacing these sidewalks, which will provide more even surfaces for pedestrian travel. We also recommend repairing brick surfaces over time as the brick degrades with a cheaper material known as pressed concrete. This will provide a more even surface while at the same time provide a similar aesthetic appeal. The ADA advises against any uneven surface including brick and suggests replacements and repairs to challenges such as these.

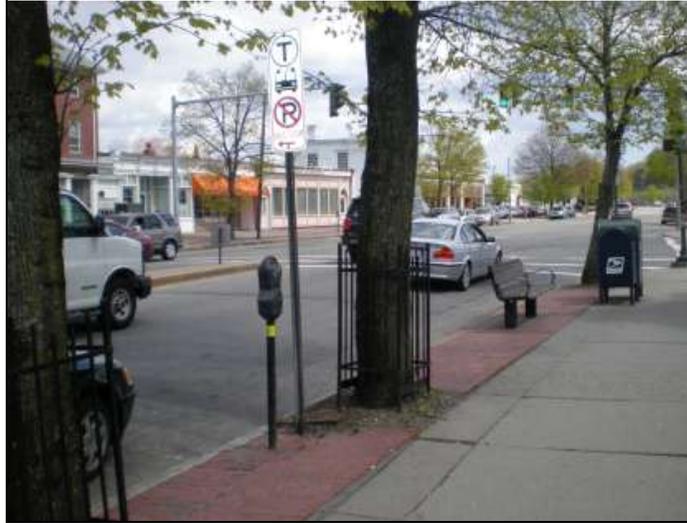
Figure 6: Bus Stop

- 9. Lack of a Proper Bus Stop:** This bus stop lacked a full shelter and bike racks, making this facility less appealing, as displayed in Figure 13.

Recommendation: Implement full bus shelters: We recommend making bus stops more appealing to pedestrians and bicyclists through implementing full bus shelters and bike racks throughout Newton.
