## West Newton

Dangerous interactions between congested vehicle traffic and pedestrians are common throughout West Newton. Additionally, many pedestrians choose their own crossings rather than using the designated crosswalks and walking lights. Other opportunities West Newton presents are improved accessibility to the commuter rail station, implementation of better bus shelters and bike racks, and the implementation of new crosswalks that could inform drivers where pedestrians are likely to cross. These problems and opportunities occur throughout this area including at each intersection of interest.

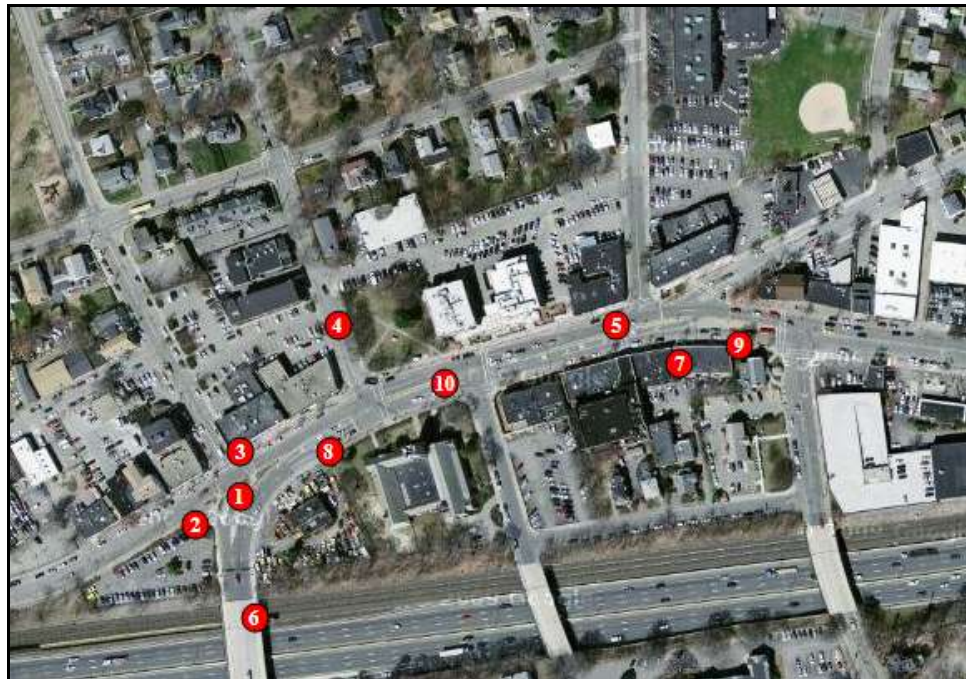
**Figure 1: West Newton Problems and Opportunities Map**

We focused on four streets that intersect with Washington Street. In this section, we discuss the areas for improvement as well as potential solutions. Below is a map detailing where areas for improvement exist in West Newton.

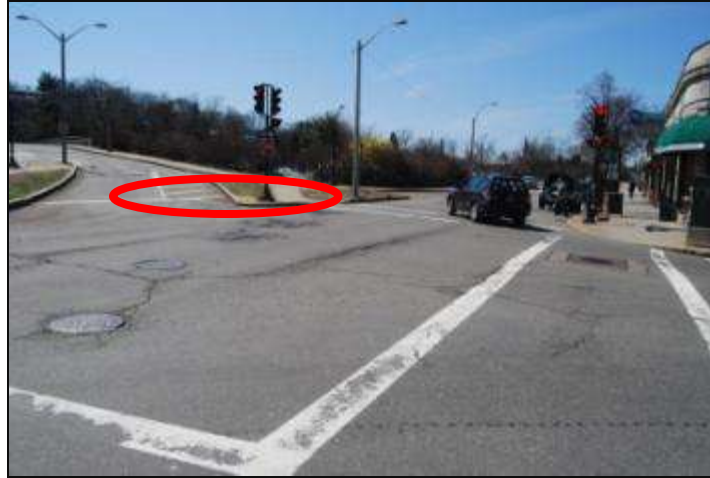
**Figure 2: Potential New Crosswalk Location**

- 1. Confusing Crosswalk Design:** The crosswalks at this intersection do not represent the paths pedestrians normally take and are not in the safest place for crossing through this area, as shown in Figure 9.

*Recommendation: Implement a new crosswalk.* We recommend implementing a new crosswalk across from Elm Street at the north side of the intersection with

Washington Street. This was a common path along one lane of traffic and would provide a safe place to cross.

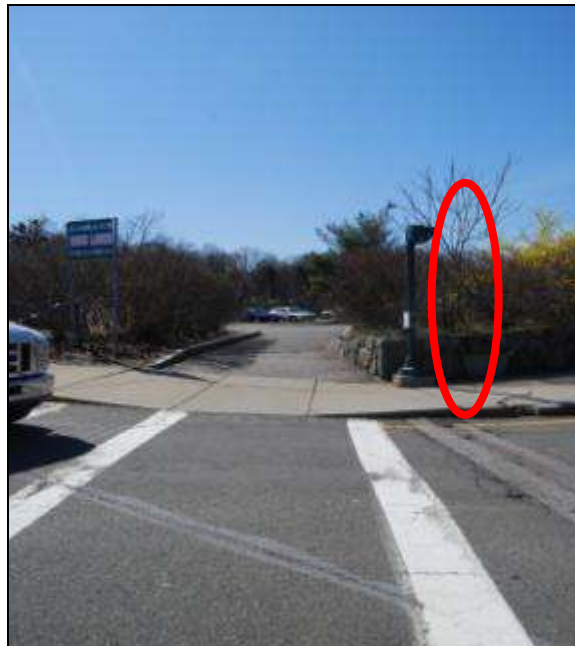
**Figure 3: Walking Light Not Visible**

- 2. Walking Light Not Visible:** As shown in Figure 10, the walking light is turned away from the crosswalk, making it impossible for a pedestrian to determine when the light indicates it is safe to cross.

*Recommendation: Rotate the walking light.* We recommend rotating the walking light back to facing the crosswalk to encourage pedestrians to use this facility.

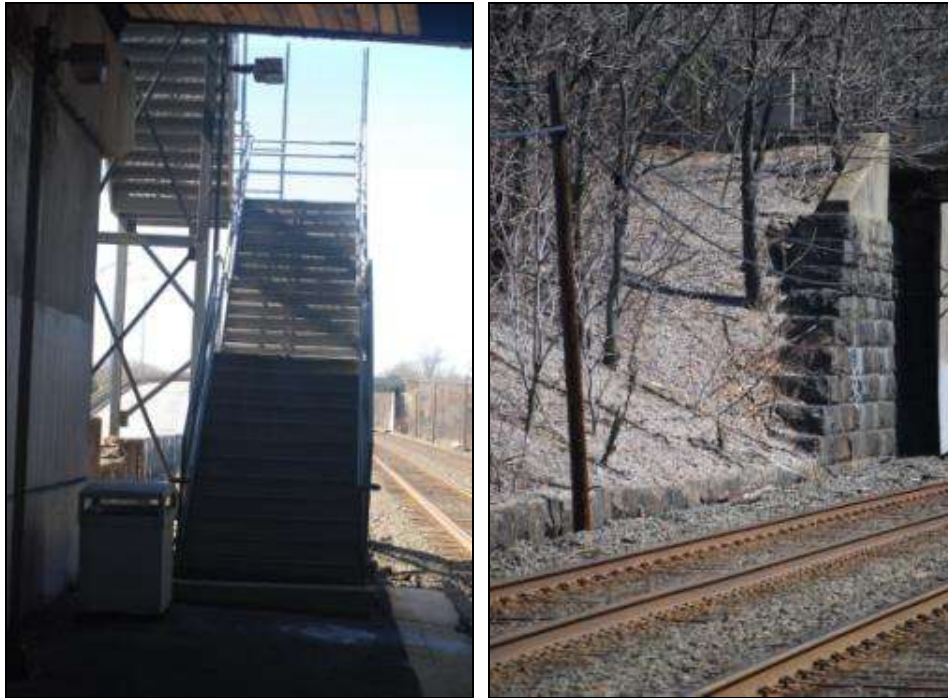
**Figure 4: Inaccessible Commuter Rail Station**

- 6. Inaccessible Commuter Rail Platform:** There are three commuter rail stops in Newton, none of which are handicap-accessible. Figure 11 shows the West Newton platform, which only has stairs leading down to it. Since the ADA requires that all public facilities be accessible to all persons, this portrays Newton in a bad light. Therefore, it is important to address this issue.

*Recommendation: Construct a ramp to the Commuter Rail platform.* We recommend that implementing a ramp at the stop in West Newton will make

Newton more accommodating to all persons. This ramp needs further planning and MBTA involvement and funding.

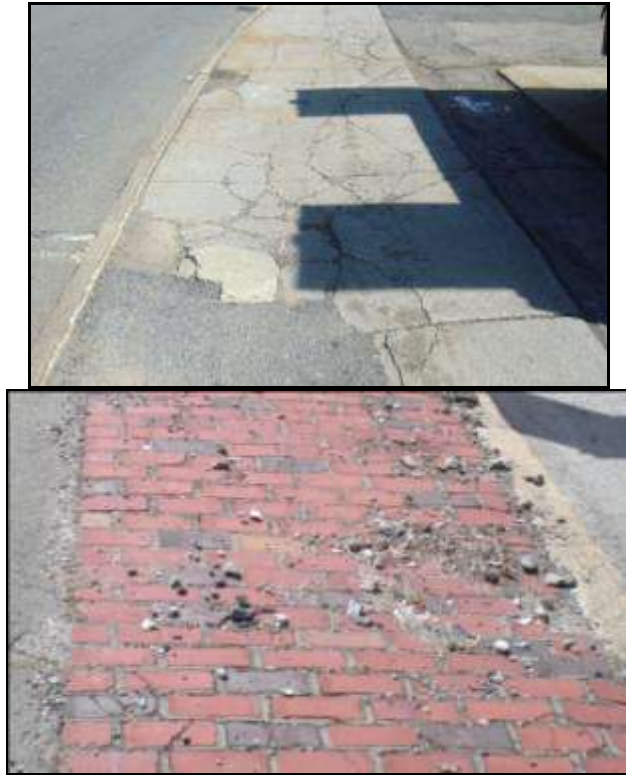
**Figure 5: Cracked Sidewalk (left); Poorly maintained brick (right)**

- 8. Sidewalks in Poor Condition:** The sidewalks in West Newton are generally in good condition; however, some areas feature cracked and broken sidewalks, as shown in Figure 12, creating tripping hazards that are particularly dangerous to the elderly and the disabled. At the same time, many sidewalks are lined with brick buffers and brick curb cuts.

*Recommendation: Repair or replace sidewalks:* We recommend repairing or replacing these sidewalks, which will provide more even surfaces for pedestrian travel. We also recommend repairing brick surfaces over time as the brick degrades with a cheaper material known as pressed concrete. This will provide a more even surface while at the same time provide a similar aesthetic appeal. The ADA advises against any uneven surface including brick and suggests replacements and repairs to challenges such as these.

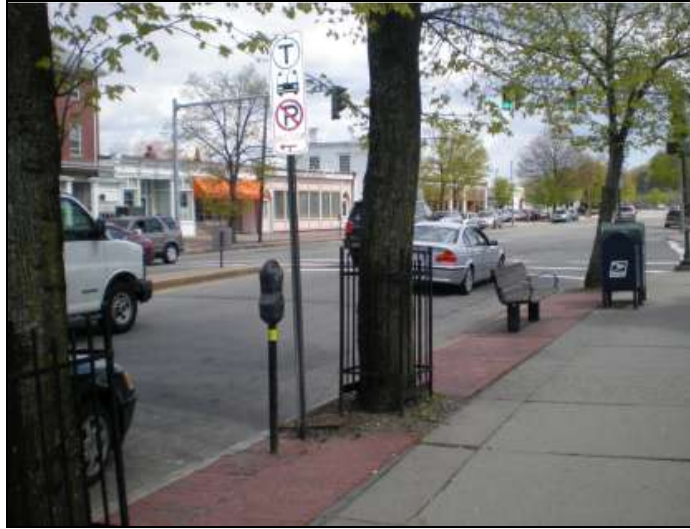
**Figure 6: Bus Stop**

- 9. Lack of a Proper Bus Stop:** This bus stop lacked a full shelter and bike racks, making this facility less appealing, as displayed in Figure 13.

*Recommendation: Implement full bus shelters:* We recommend making bus stops more appealing to pedestrians and bicyclists through implementing full bus shelters and bike racks throughout Newton.
