### 4.3 Newton Centre

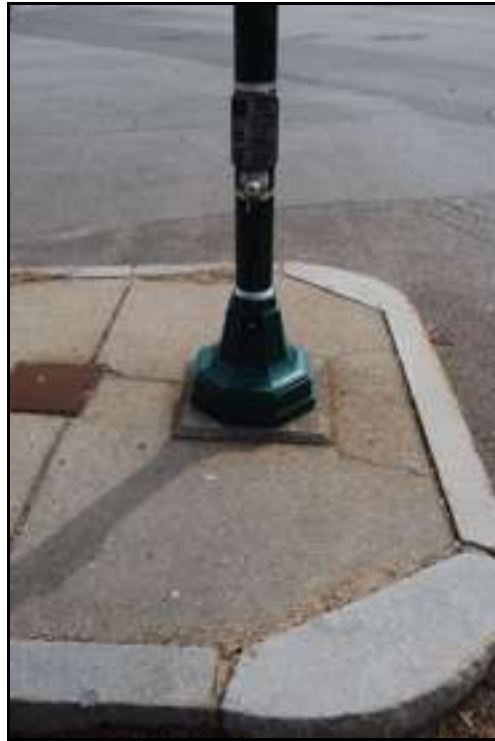
- 1. Inaccessible Walking Light Button Located on Median:** The median located where Langley Road begins to intersect with Beacon Street and Sumner Street currently has a cut-through so that pedestrians do not need to step on the median, while still separating them from vehicular traffic. Located on this median is a walking light, as shown in Figure 27. The challenge that pedestrians face here is

there are no curb cuts allowing access to the walking light; this prevents people from crossing this street safely. Our recommendations shown below for this challenge are two options that could be implemented:

**Figure 2: Walking light located on top of an inaccessible median at the intersection of Langley Road and Beacon Street**

*Recommendation: Install a Curb Cut.* We recommend installing a curb cut onto the median to allow access for everyone to use the walking light.

*Recommendation: Relocate the walking light:* We recommend relocating the walking light to the edge of the median so it is accessible to pedestrians traveling through the pre-existing cut-through.

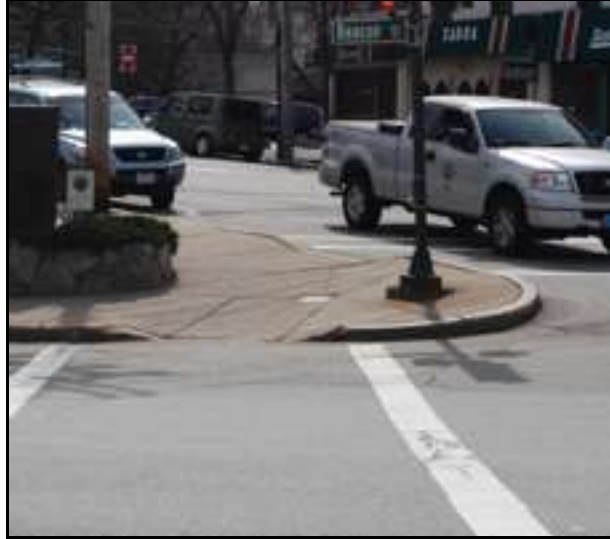
- 2. Steep Slope of Curb Cut and Long Crosswalk:** When traveling east through this intersection, where Langley Road and Beacon Street begin to separate, there is a curb cut that has a sharp slope, shown in Figure 28. This impedes those with walking disabilities from accessing the sidewalks located on the respective streets, forcing many people to walk in the street instead of utilizing the crosswalk. At this intersection, we observed many people avoiding this curb cut. This is extremely unsafe as it is forcing pedestrians to interact with vehicles. Also located at the steep curb cut is a long crosswalk crossing Beacon Street on the east side. Long crosswalks present the challenge of crossing the street in enough time to avoid vehicular traffic.

**Figure 3: Steep curb cut located at the intersection of Langley Road and Beacon Street**

*Recommendation: Implement a sidewalk extension into Beacon Street:* We recommend implementing a sidewalk extension, known as a “bulb-out”, which would create a shorter distance for pedestrians to travel along the long crosswalk. Also, by creating a larger pedestrian facility, there may be enough room to design a more accessible curb cut in order for people to use the sidewalks in the area.

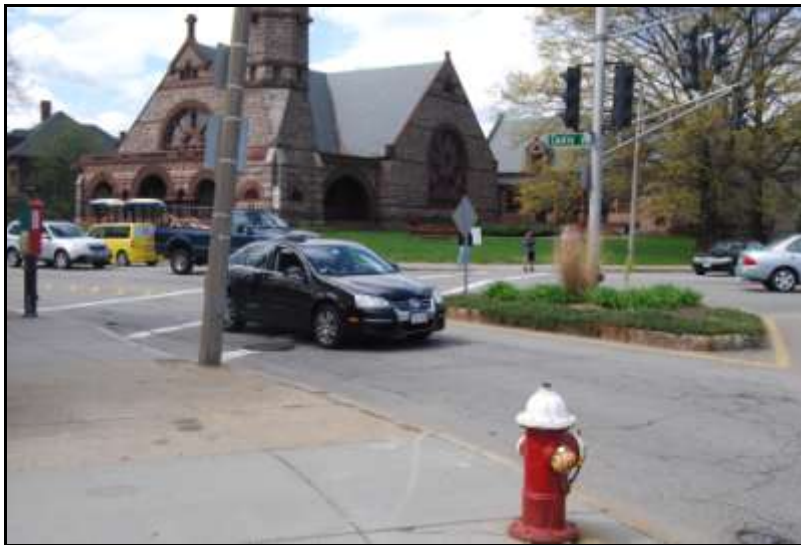
- 3. Dangerous Conditions caused by Right-on-Red:** One of the major challenges that pedestrians face in this intersection is competition with vehicles heading northbound on Centre Street attempting to take a right turn onto Beacon Street while having a red traffic signal, seen in Figure 29. We observed pedestrians attempting to cross with the walking signal however they were stopped by vehicles taking right-on-reds. The following recommendations represent alternatives for improvement.

**Figure 4: Car making a Right-on-Red at Centre Street and Beacon Street**

*Recommendation: Eliminate the right-on-red:* We recommend eliminating right-on-reds. This will eliminate competition between pedestrians and vehicles and thus create a safer crossing for pedestrians.

*Recommendation: Redesign the Corner.* Another option would be creating a sharper corner where vehicles take a right-on-red. The corner should be well squared forcing motorists to slow down when taking the right turn, increasing the safety of pedestrians crossing.

*Recommendation: Install a “No Turn on Red” traffic signal.* A third option is the installation of a signal that will only be activated when pedestrian use the walking

light. This will allow a safe way for pedestrians to cross the street and eliminates all competition between pedestrians and vehicles.

*Recommendation: Install “Leading Interval” traffic lights:* Finally, we recommend the installation of *leading interval traffic lights* that are synchronized with the walking light. Once the walking signal is activated, the traffic signals will be red long enough to provide enough time for a pedestrian to travel half way across the street before letting vehicular traffic start again. This provides a safe way to cross the street and also prevents vehicular traffic congestion by allowing traffic to continue when the pedestrian is using the second half of the crosswalk.

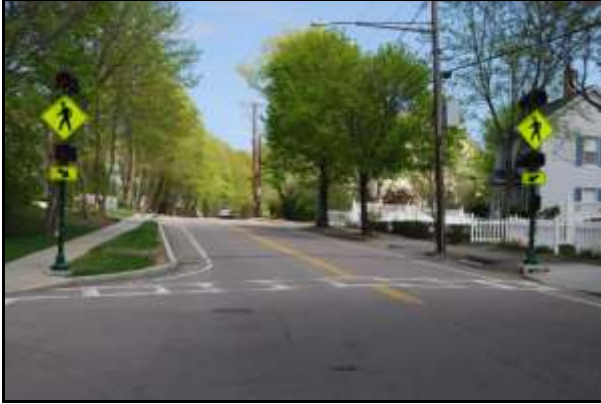
When conducting our study on improving pedestrian mobility in Newton Centre, we were also asked to determine if the installation of a new pedestrian beacon on Centre Street would be useful and if so, to determine which crosswalk would be most suitable for this beacon. We conducted a test of the effectiveness of an existing beacon at Langley Road and Langley Path by comparing safety at that crossing to that at Parker Street and Daniel Street, a similar location without a beacon, both shown in Figure 31. We found that at the crosswalk with the pedestrian beacon, 53% of cars stopped for pedestrians who had activated the beacon and stepped into the crosswalk. At the crosswalk with no beacon, only 12.5% of cars stopped for a pedestrian in the crosswalk under similar circumstances. We concluded that the beacon is useful for notifying motorists that a pedestrian is trying to use the crosswalk, prompting the motorists to yield for those attempting to cross.

**Figure 5: Pedestrian Beacon at Langley Road and Langley Path**
