## Newton Corner

In this study area, we noticed many problematic patterns that involved inaccessibility and unsafe facilities. This included poor surface conditions, and an inaccessible path through the Crowne Plaza Hotel. Also, curb cuts and signals were not always designed to the accessibility standards provided by the ADA. In this section, we discuss the areas for improvement found in Newton Corner as well as potential solutions for these problems, as shown in Figure 15.

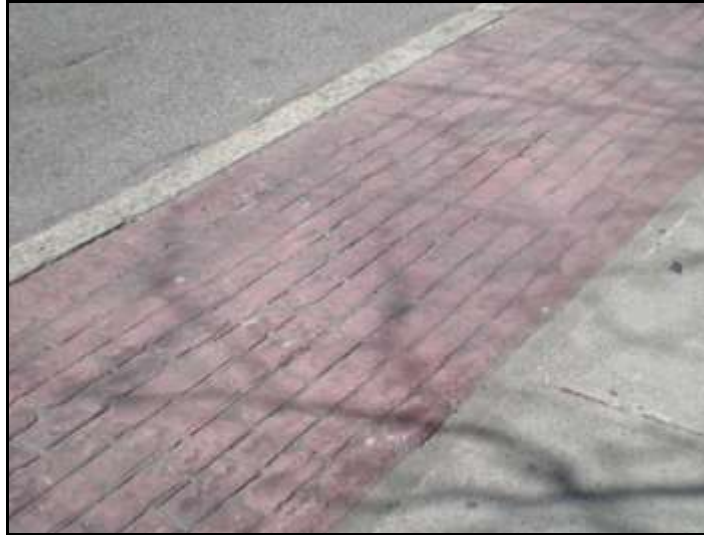
**Figure 3: Pressed concrete on Washington Street in Newton Corner**

- 2. Hazardous Brick Surfaces:** Washington Street, for example, has a partial brick surface, as shown in Figure 16. Brick surfaces are extremely difficult to maintain and can be hazardous. The ADA suggests uneven surfaces such as bricks should be avoided.

*Recommendation: Replace with pressed concrete.* We recommend replacing the brick surfaces with pressed concrete. Pressed concrete maintains some of the aesthetic appeal of brick while providing a safer traveling surface. This can be implemented systematically over time. As the brick degrades, pressed concrete could be used as a replacement. An example of pressed concrete is shown below in Figure 17.
